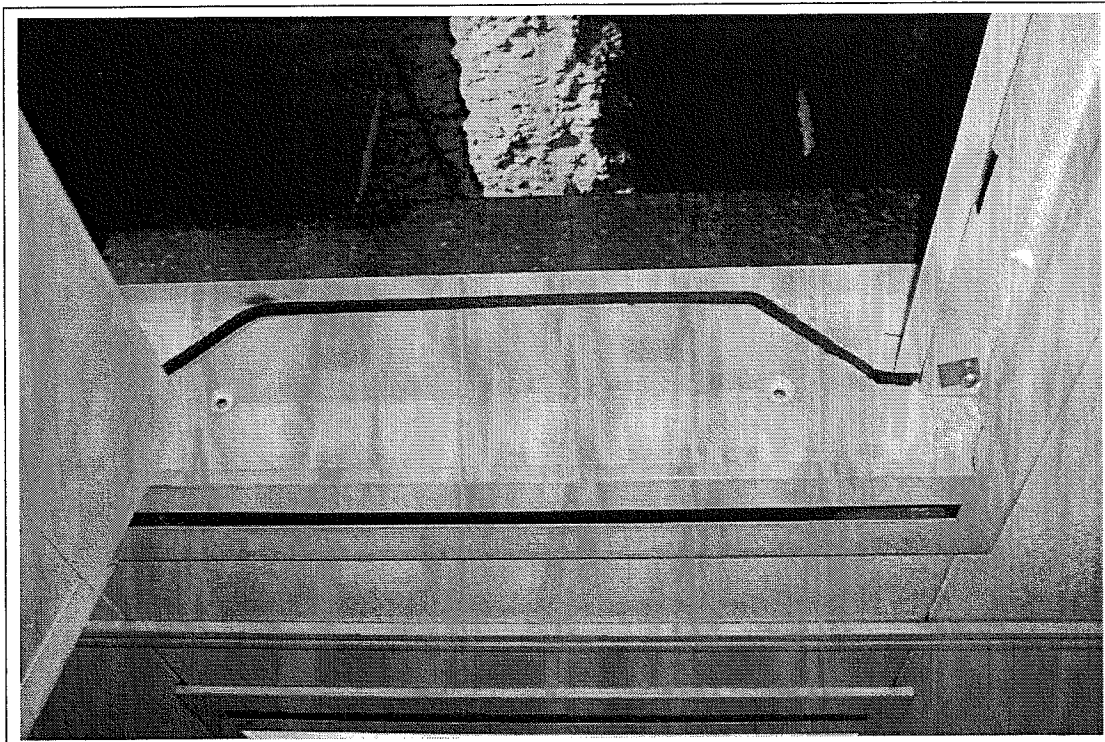
Photo 68. 21st floor, adjacent to room N2132A - View of fireproofed sprayed beam above suspended ceiling

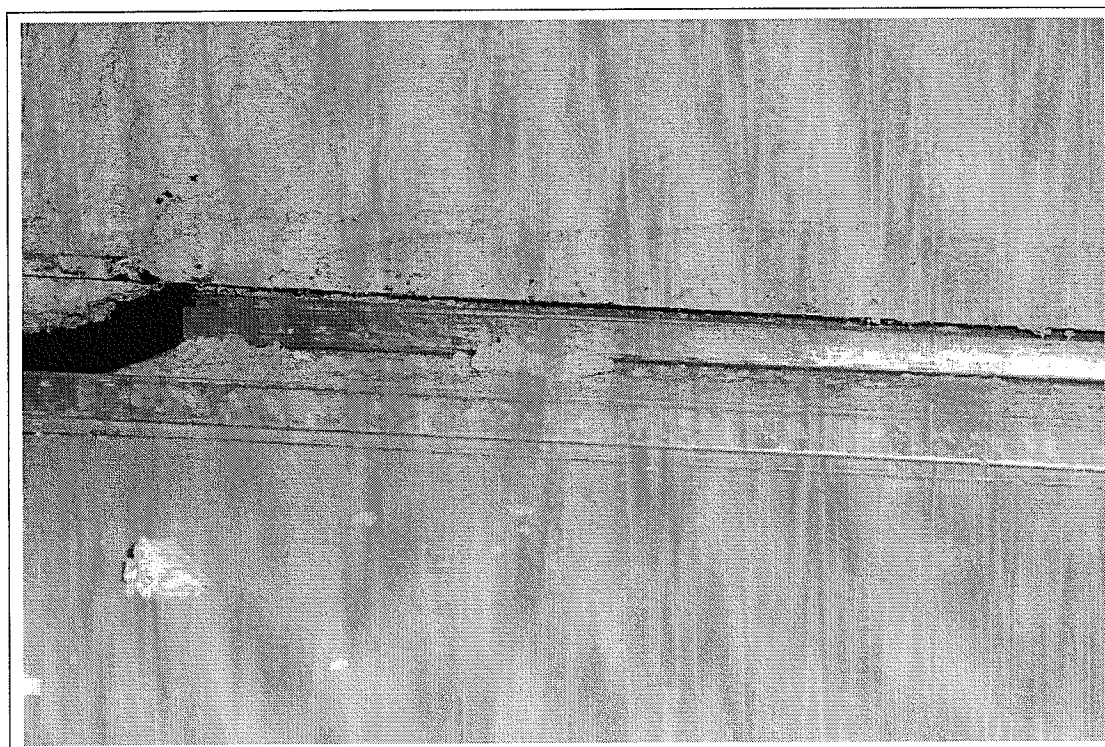
Photo 69. 6th floor, adjacent to room S601 - View of delaminated fireproofing debris on top of suspended ceiling

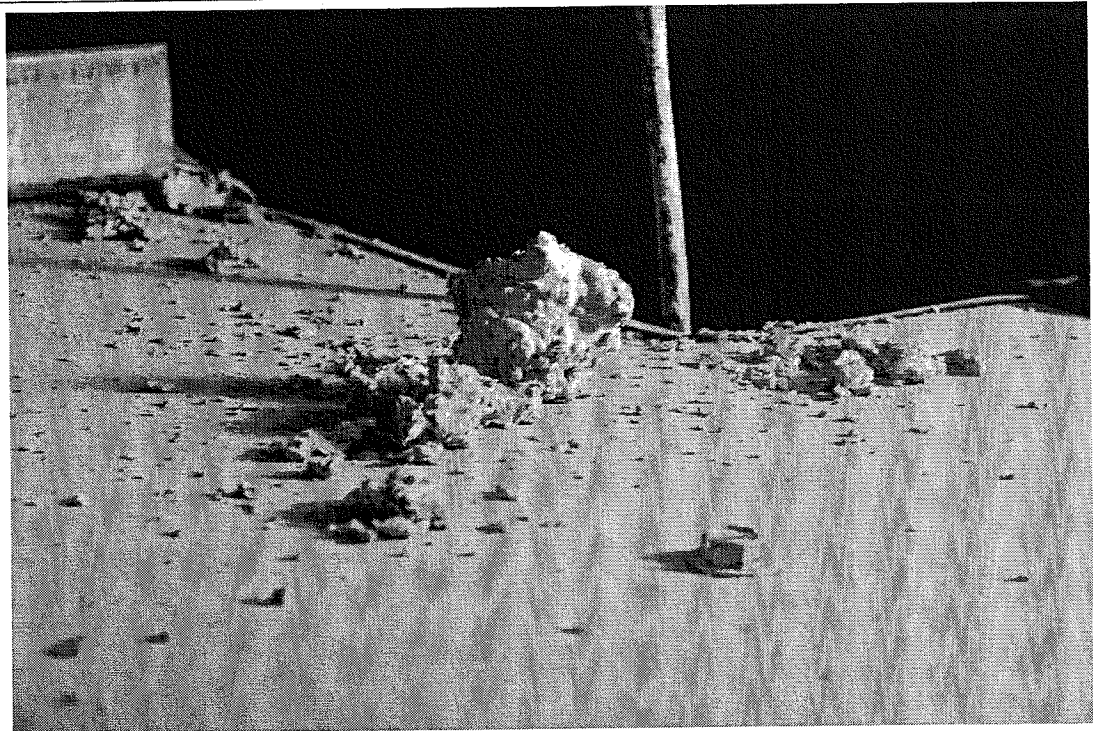
Photo 70. 6th floor, adjacent to room S601 - Close-up of delaminated fireproofing debris on top of metal HVAC duct

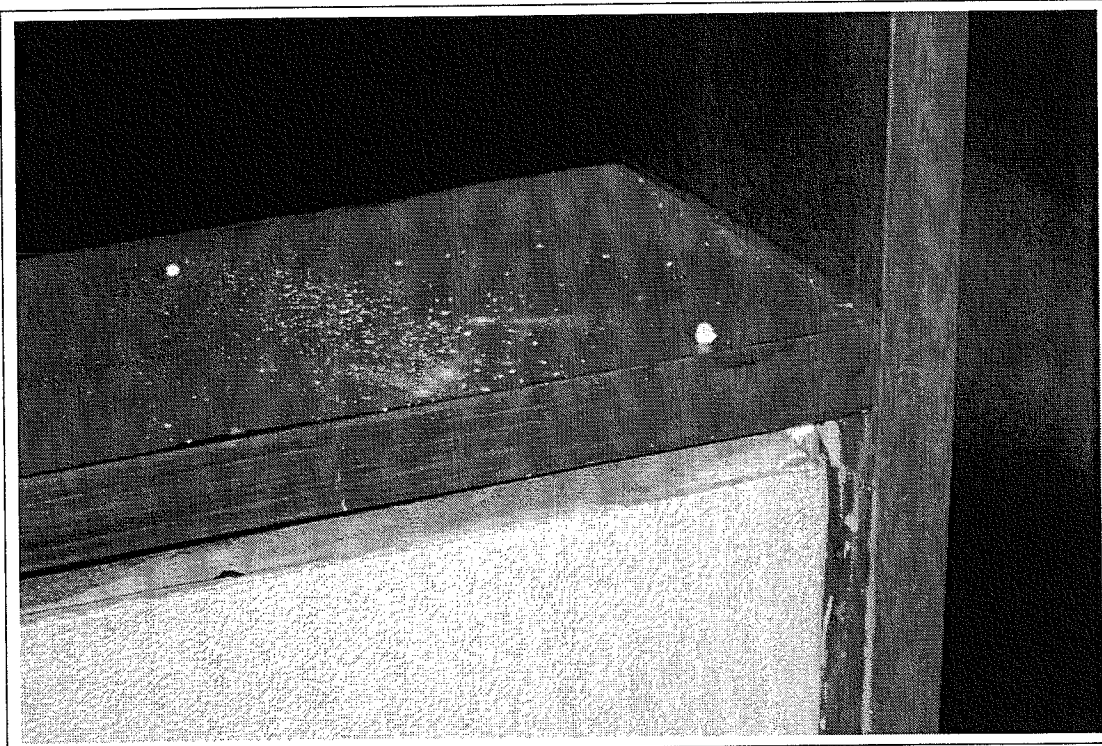
Photo 71. 17th floor, elevator lounge area - Location of dust sample #4 (top of room partition beneath acoustical plaster ceiling)

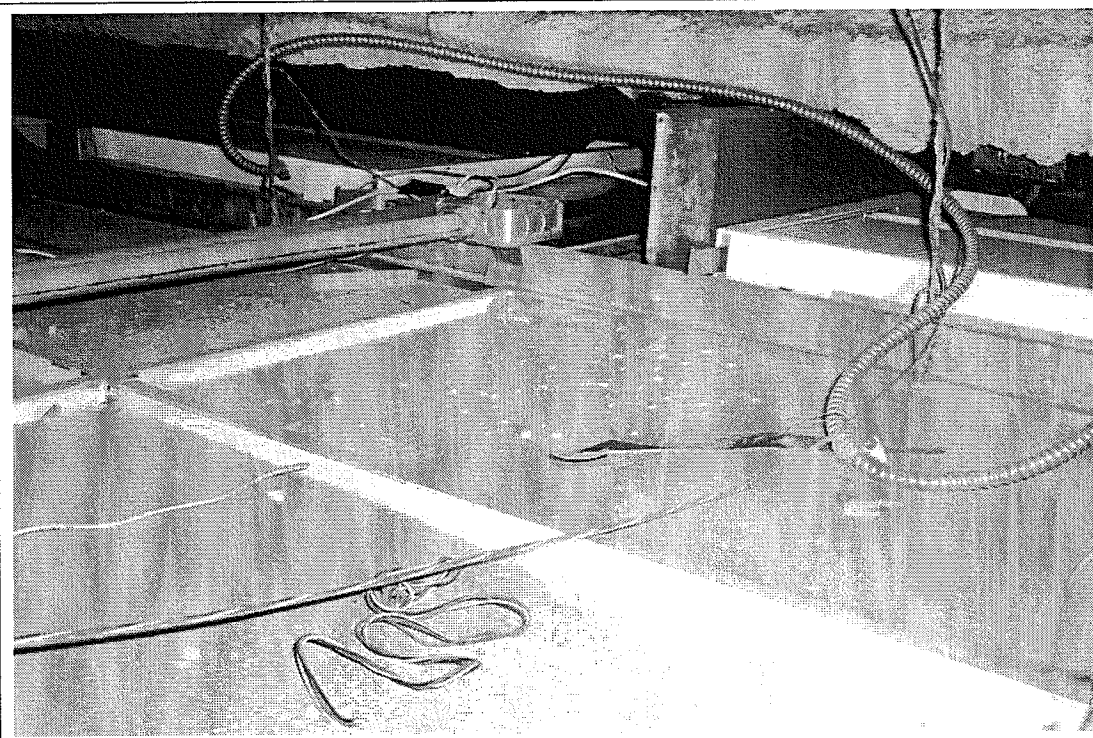
Photo 72. 12th floor, adjacent to room E1244A - View of delaminated fireproofing debris on top of suspended ceiling

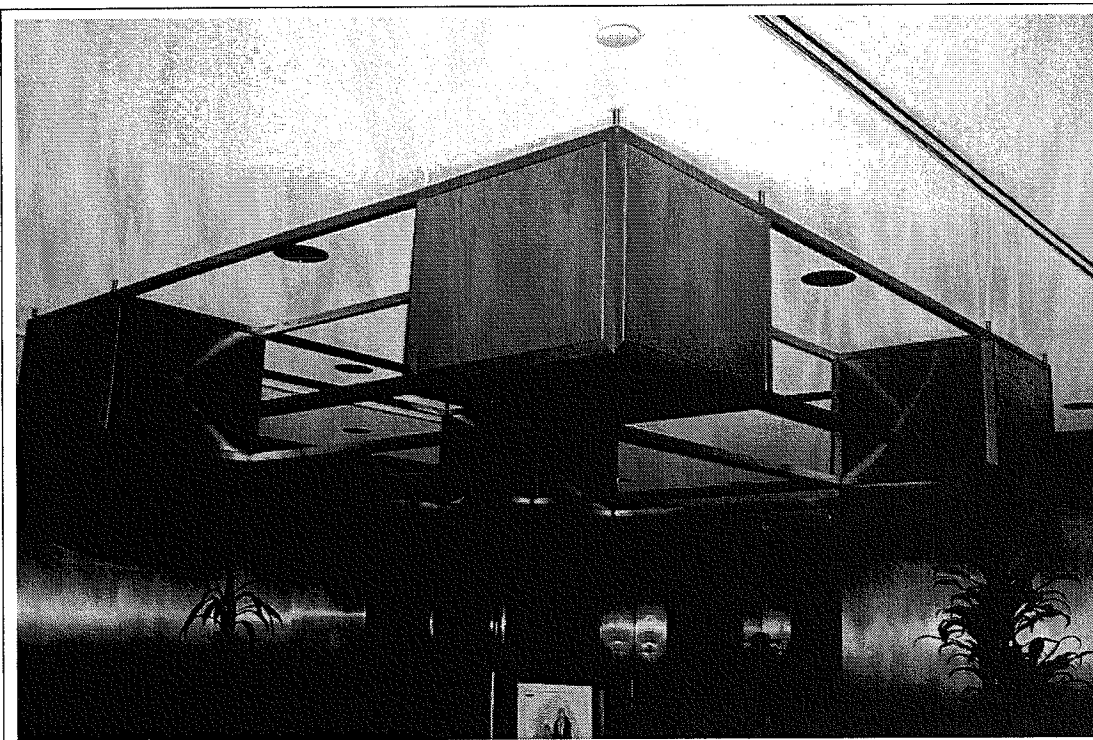
Photo 73. Basement lobby – Decorative attachments to acoustical plaster ceiling
